**Five-Year Review Report  
For  
Pinette's Salvage Yard Superfund Site  
Aroostook County, Maine**

**September 2005**

Region I  
United States Environmental Protection Agency  
Boston, Massachusetts

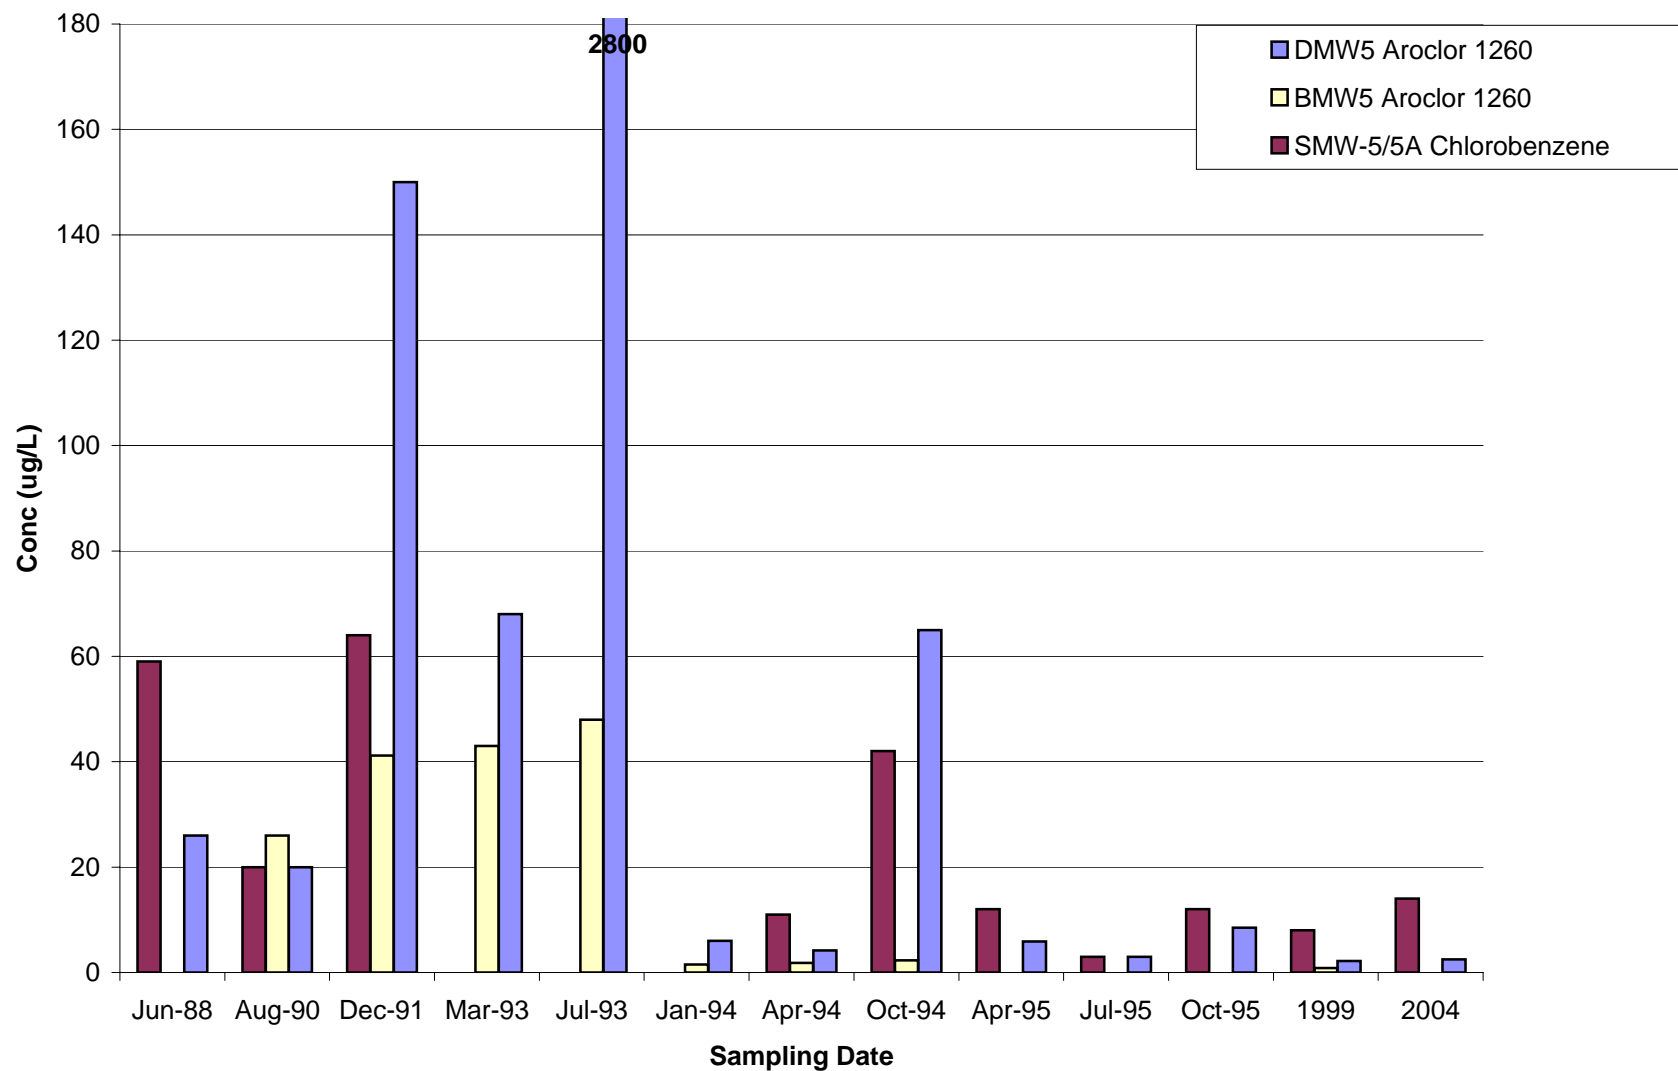
**Figure 1**  
**Long Term Concentration Trends**

Figure 1 presents a comparison of the longer term trends for Arochlor 1260 in wells DMW-5 and BMW-5 within well cluster #5 in the center of the Site. Also included is longer term trend data for chlorobenzene for well SMW-5/5A. The results indicate that since the completion of the source control remedial action in 1993, the concentrations for these compounds have been relatively constant. Beginning with the January 1994 data, and with the exception of the October 1994 data, the concentrations in groundwater are well below the levels prior to the source control remedial action. The more recent long term trend at the Site shows a low but persistent level of PCB contamination in the DMW and BMW wells.

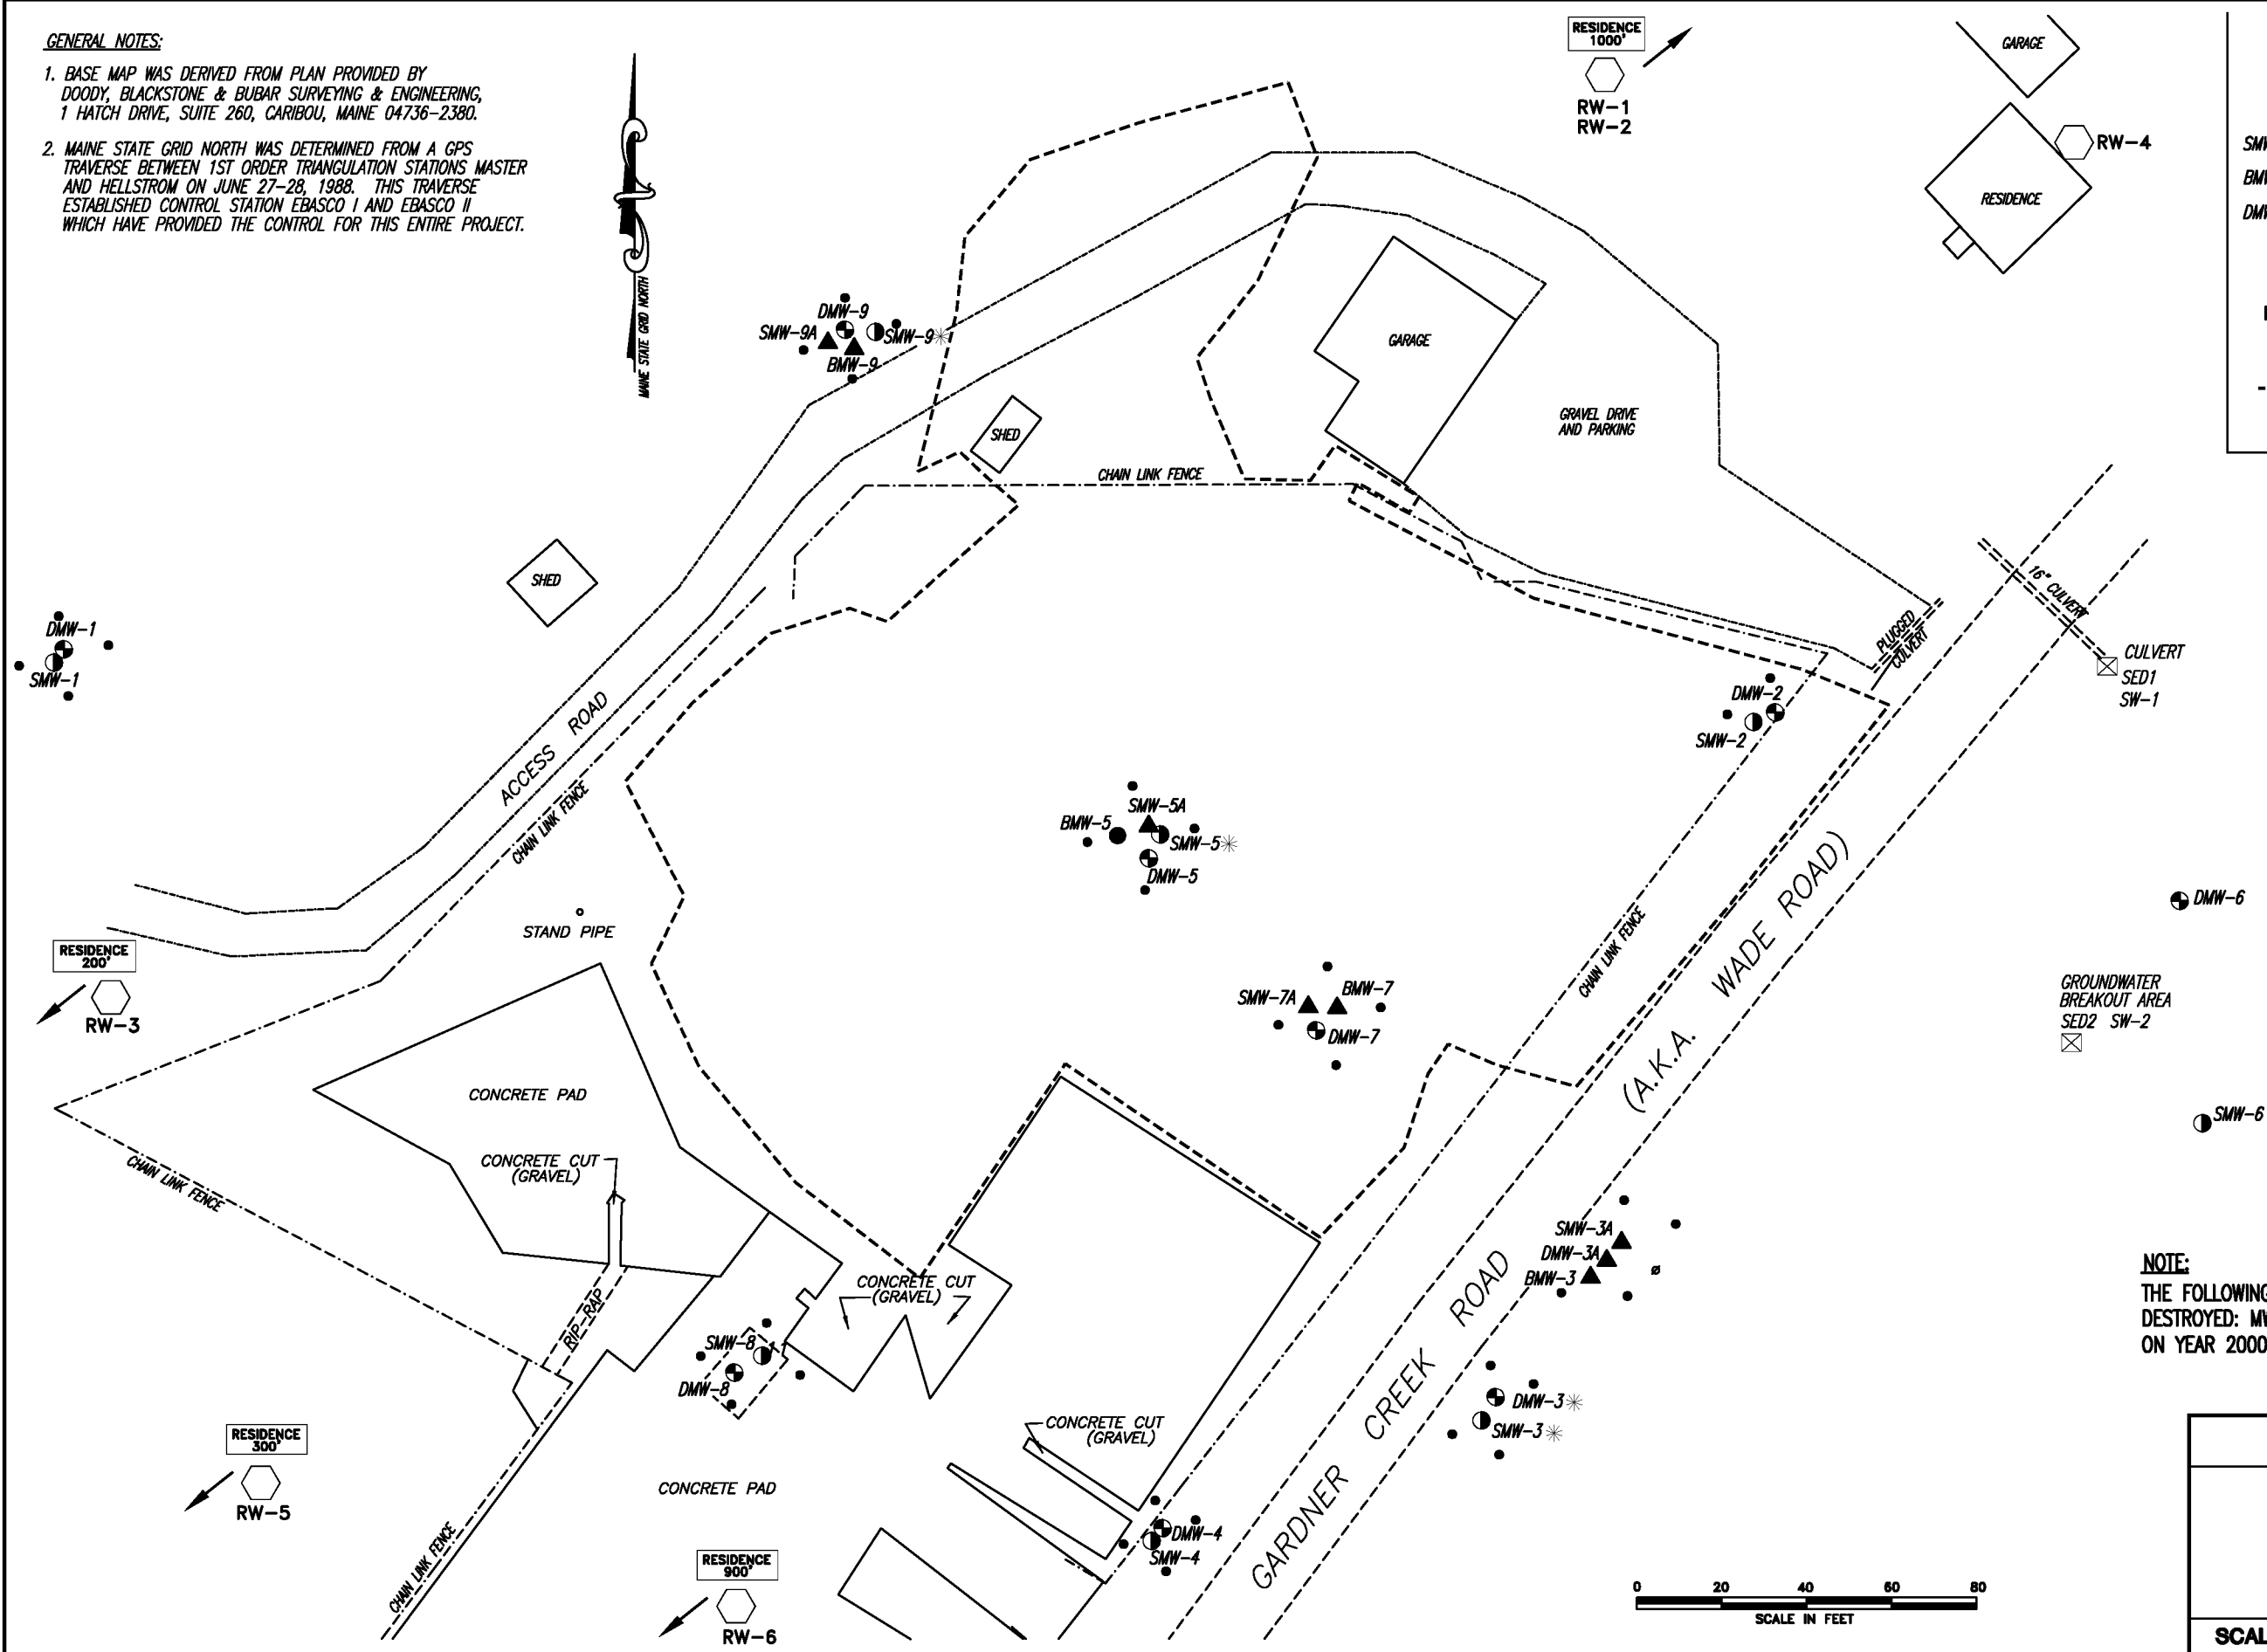
**ATTACHMENT 3**

NOTE:  
THE FOLLOWING WELL CLUSTERS HAVE BEEN DAMAGED OR DESTROYED: MW-3, MW-4, MW-9, AND SMW-7A. BASED ON YEAR 2000 SITE INSPECTION.
